INDAR (ANAMUR ALAKÖPRÜ HES)
17325 KVA GENERATOR TEST REPORT
05-04-2017

MÜŞTERİ/ Customer : İNDAR (ANAMUR ALAKÖPRÜ HES)

CİHAZ/Equipment : GENERATÖR

ELECTRICAL DIAGNOSTIC REPORT

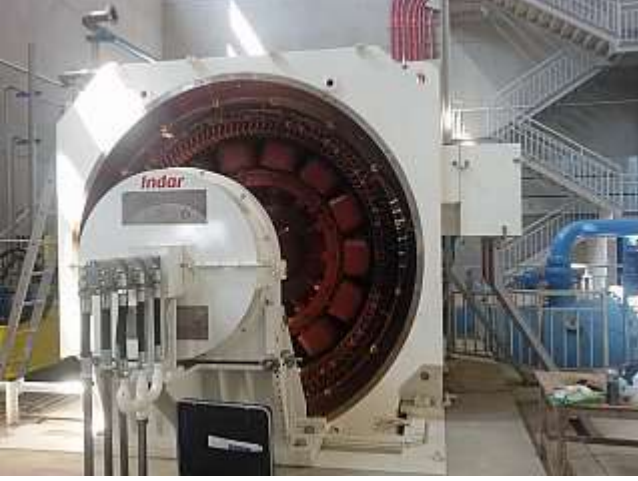
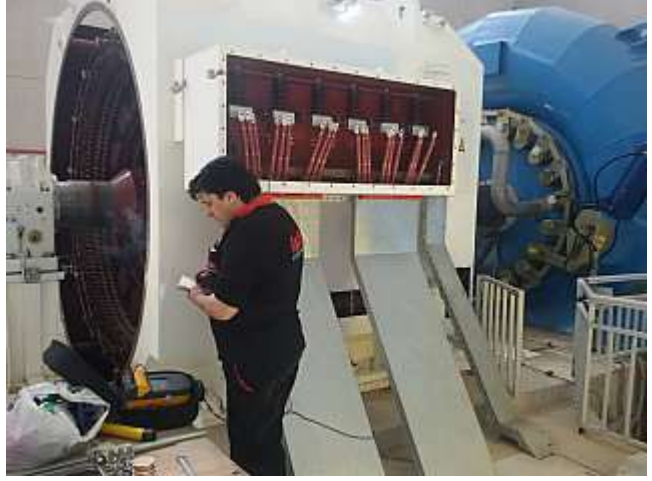
STATOR COILS INSULATION TESTS ARE PERFORMED.

MEGGER TESTİ (MΩ)	U1 - ŞASE	V1 - ŞASE	W1 - ŞASE	
GERİLİM/Voltage V	1000	1000	1000	
SICAKLIK/Temp. °C	24	24	24	
ZAMAN/Time (sn.-sec.)	15.	5,3	39	736
	30.	6	41	992
	45.			
	60.	6,81	43,5	1210

STATOR COILS INSULATION RESISTANCE VALUES ARE MEASURED.

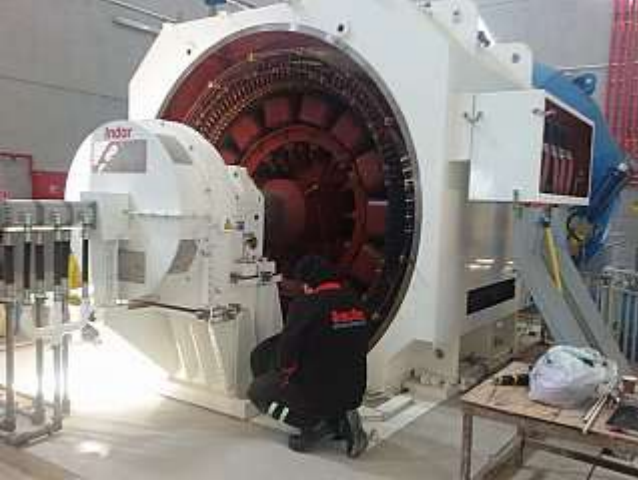
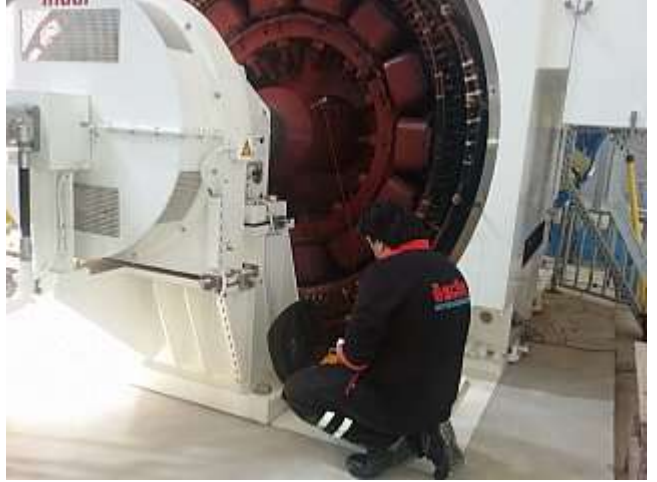
ROTOR POLES INSULATION RESISTANCE VALUES ARE MEASURED.

MEGGER TESTİ (MΩ)	ROTOR - Ş	
GERİLİM/Voltage V	500	
SICAKLIK/Temp. °C	24	
ZAMAN/Time (sn.-sec.)	15.	1230
	30.	2060
	45.	
	60.	3270

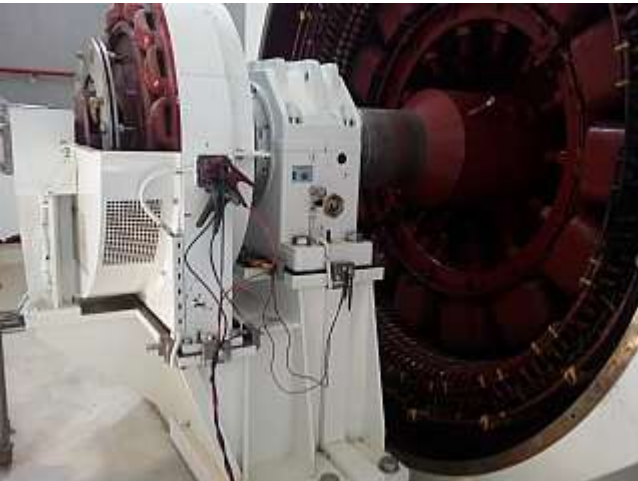
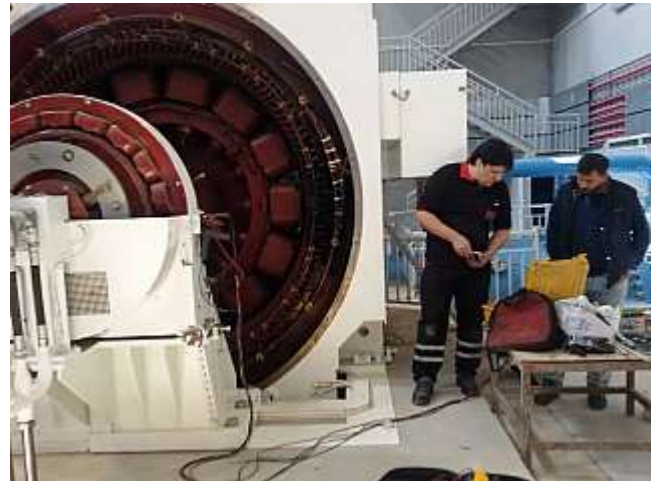
EXCITER STATOR COIL RESISTANCE VALUES ARE MEASURED.

EXCİTER STATOR DİRENCİ	Ω	7,6595
SARGI SICAKLIĞI/Winding Temperature	°C	24

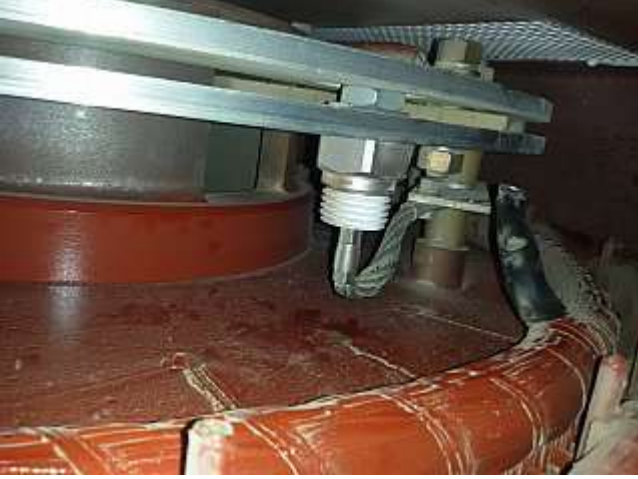
EXCITER ROTOR INSULATION VALUES ARE MEASURED.

MEGGER TESTİ (MΩ)	EXC.RT. - Ş	
GERİLİM/Voltage V	500	
SICAKLIK/Temp. °C	24	
ZAMAN/Time (sn.-sec.)	15.	685
	30.	1100
	45.	
	60.	1460

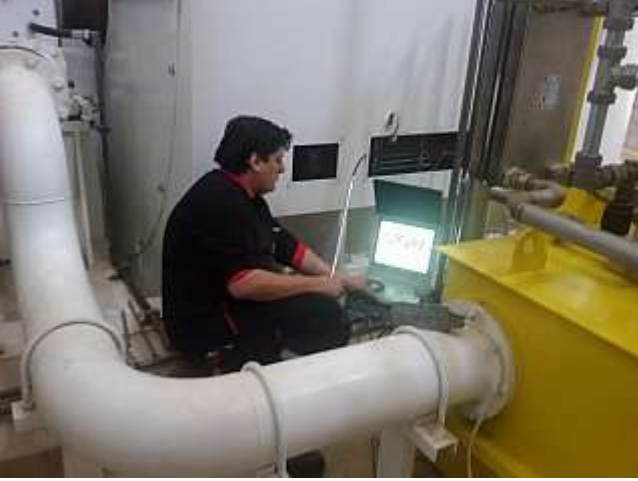
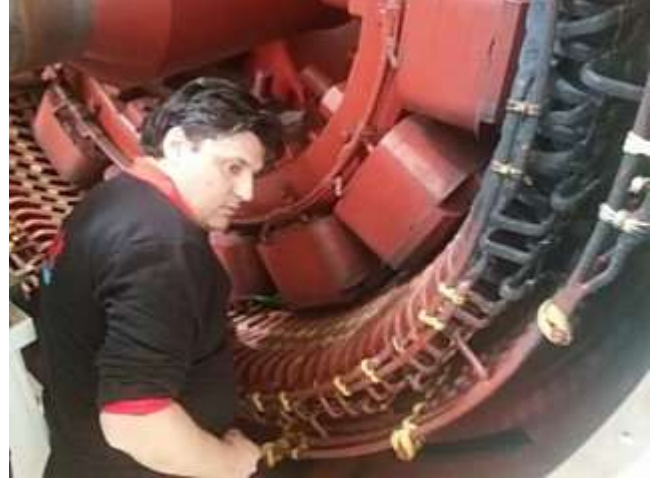
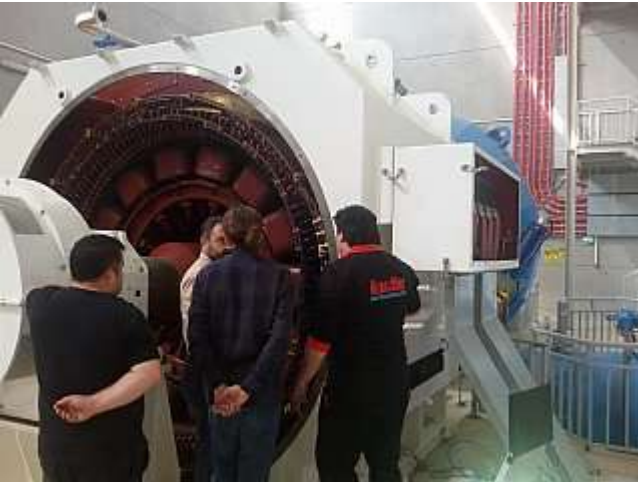
DURING VISUAL INSPECTIONS WITH OUR BOROSCOPE DEVICE NO DAMAGE HAS BEEN DETECTED EXCEPT THE SHORT CIRCUIT POINT ON MAIN GENERATOR STATOR.

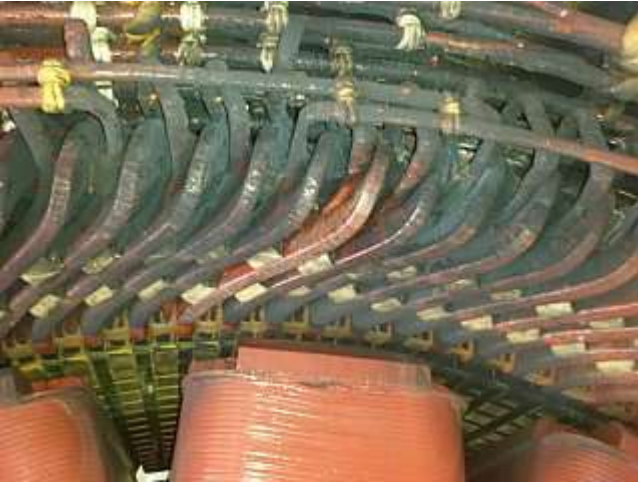
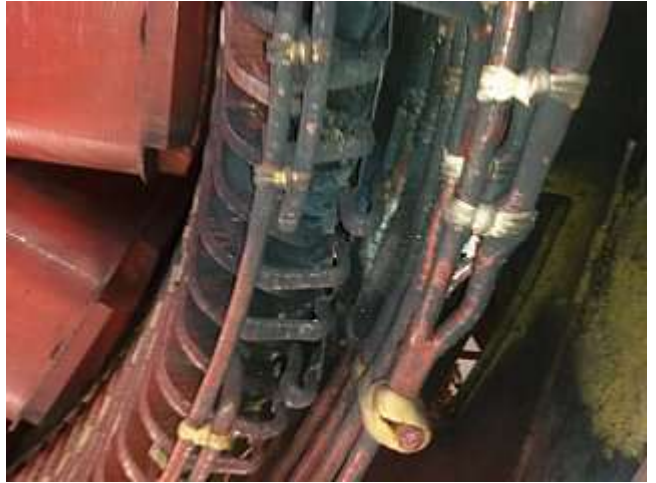
- 1- DURING INSPECTIONS AND MEASUREMENTS IT HAS BEEN DETECTED THAT THERE WAS A WATER LEAKAGE IN COOLING HEAT EXCHANGER AND IT HAS CAUSED A SHORT CIRCUIT AND EXPLOSION ON END-POINTS OF CABLES FROM STATOR COIL TO THE POWER TERMINAL BOX.

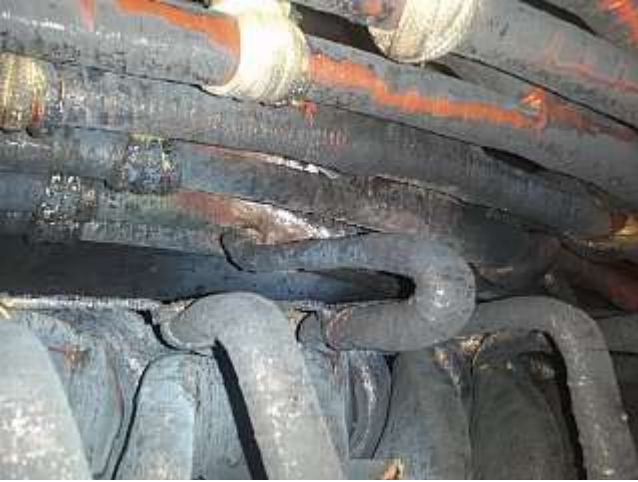
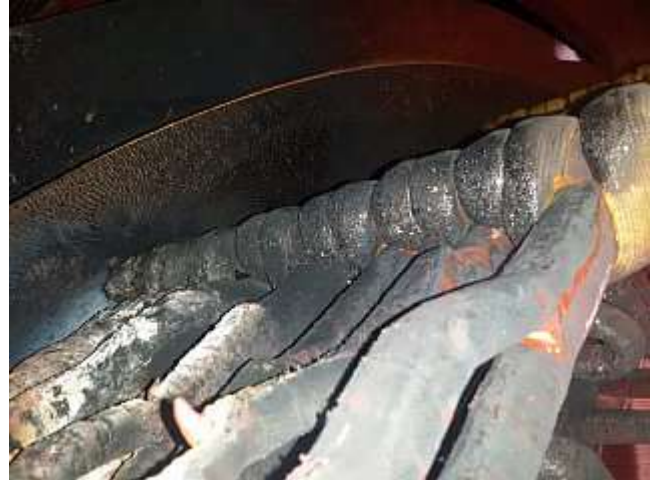
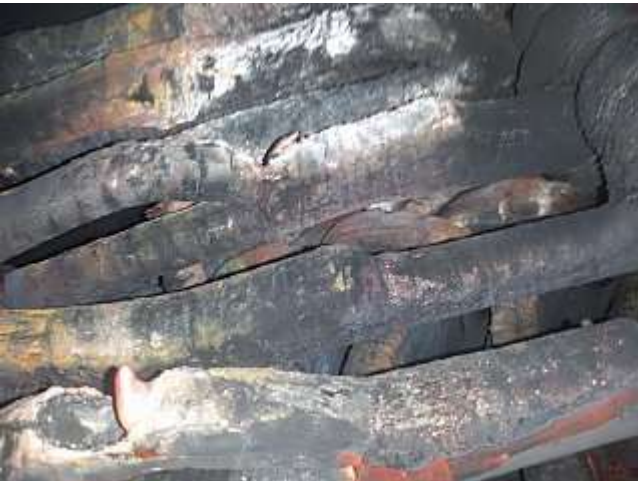
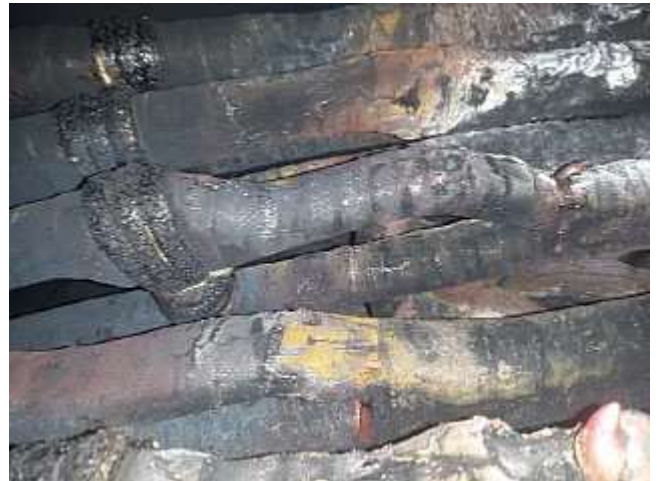
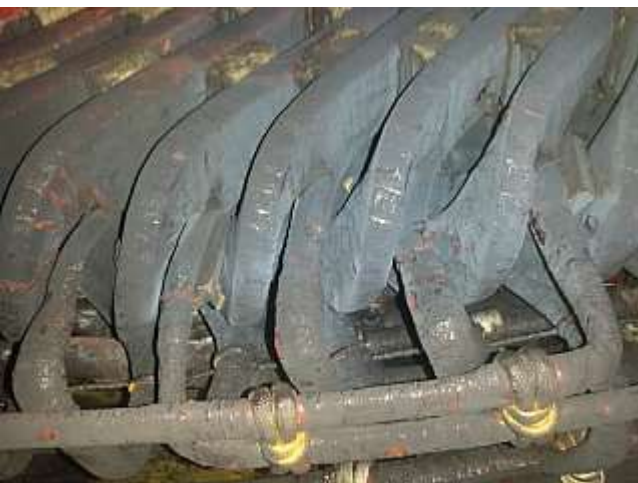
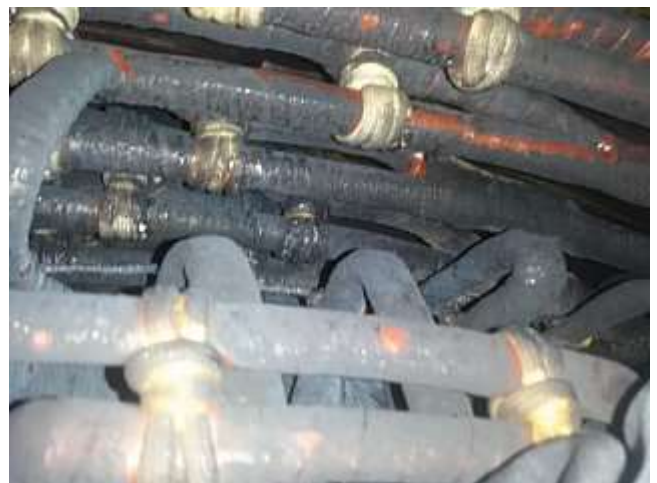
2- AFTER SHORT CIRCUIT AND EXPLOSION, THERE HAS BEEN CARBONIZED AND BURNED INSULATION POINT.
