INDAR (ANAMUR ALAKÖPRÜ HES)
17325 KVA GENERATOR TEST REPORT
05-04-2017

MÜŞTERİ/ Customer : İNDAR (ANAMUR ALAKÖPRÜ HES)

CİHAZ/Equipment : GENERATÖR

ELECTRICAL DIAGNOSTIC REPORT

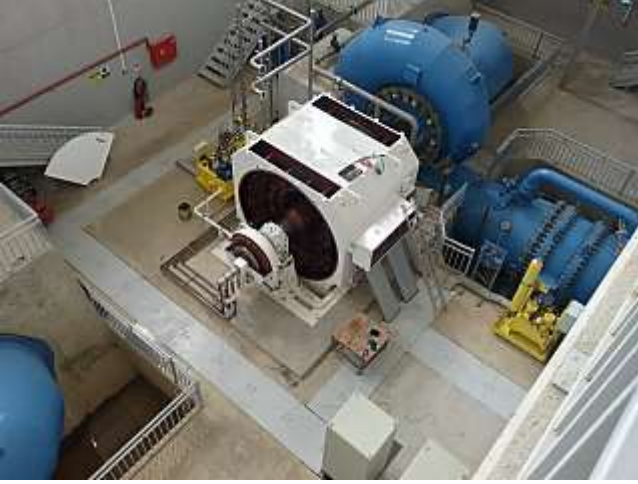
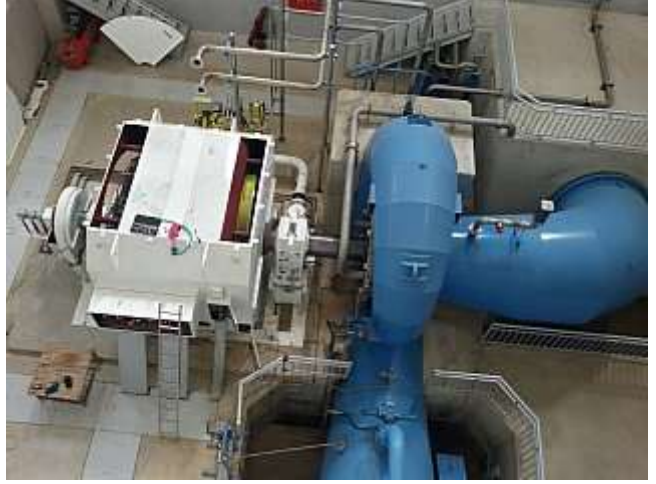
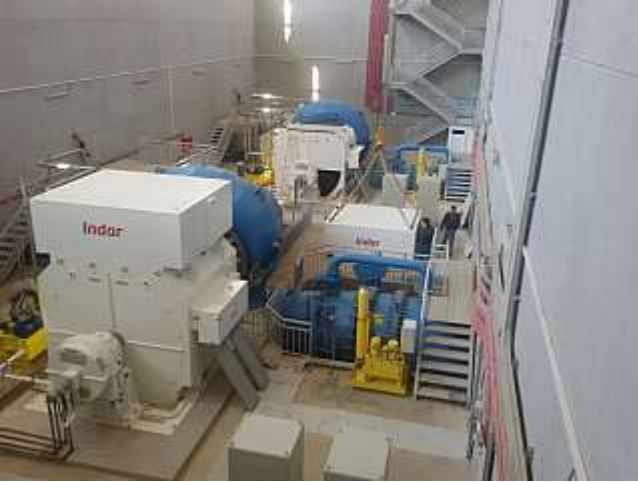
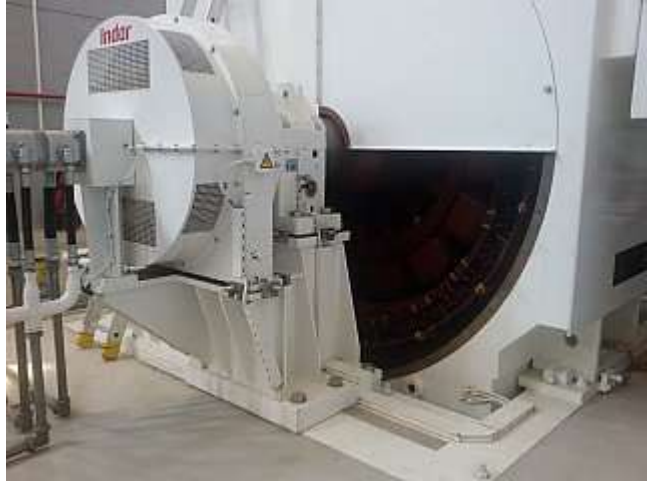
17325 KVA INDAR GENERATOR HAS BEEN ELECTRICALLY AND VISUALLY INSPECTED AFTER SHORT CIRCUIT PROBLEM AND WATER LEAKAGE DAMAGE ON HEAT EXCHANGER.

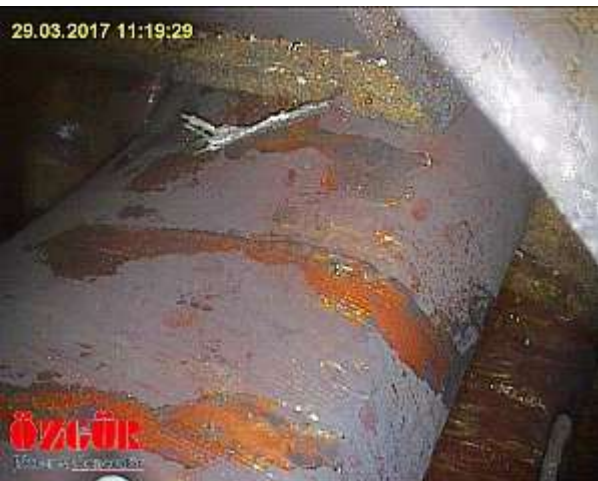
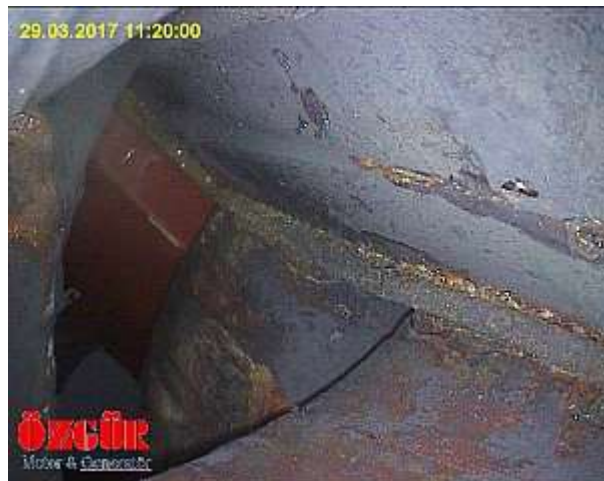
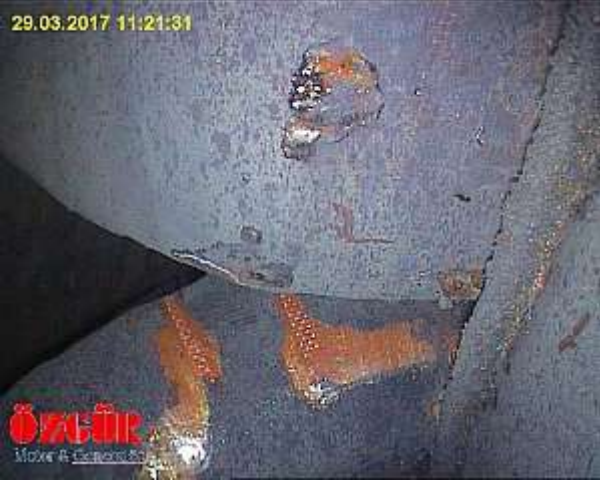
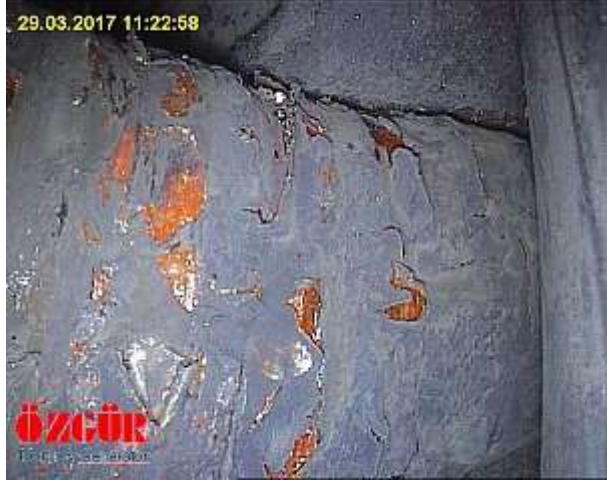
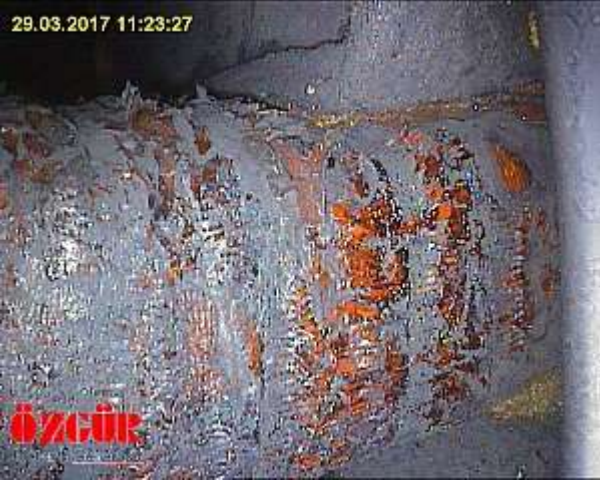
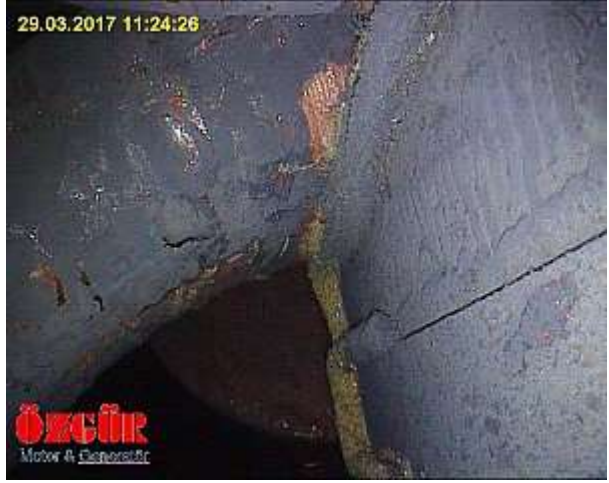
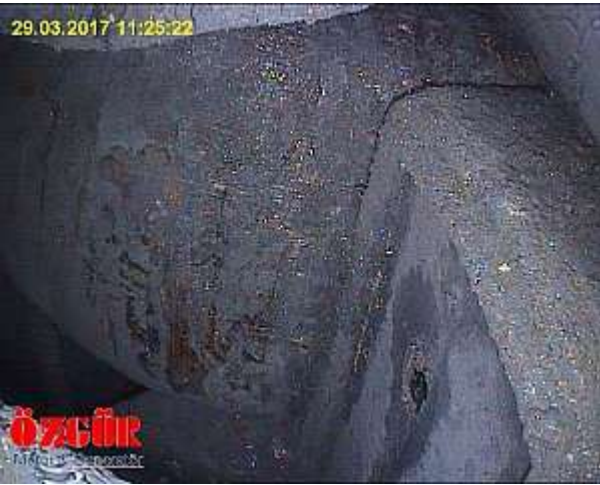
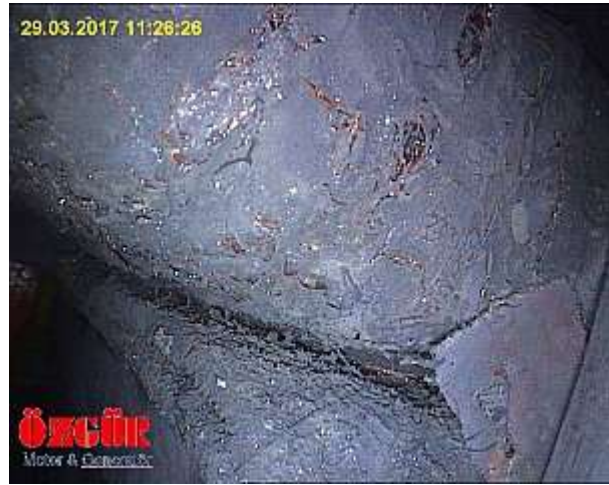
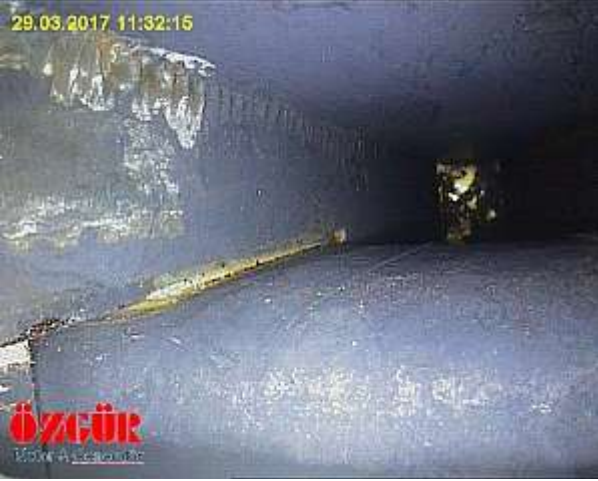
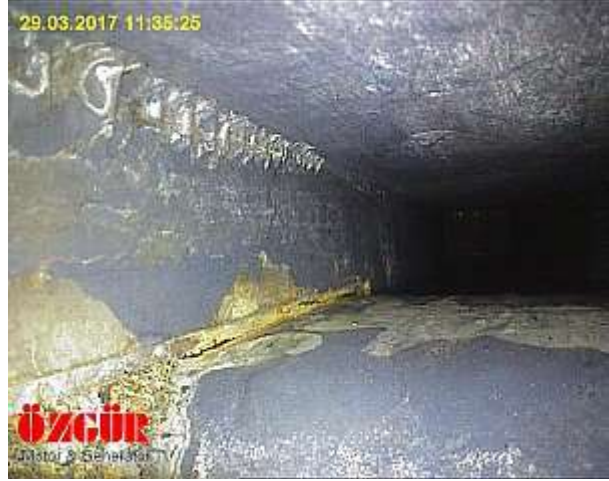
BOROSCOPE SCREEN VIEWS

DURING VISUAL INSPECTIONS WITH OUR BOROSCOPE DEVICE NO DAMAGE HAS BEEN DETECTED EXCEPT THE SHORT CIRCUIT POINT ON MAIN GENERATOR STATOR.

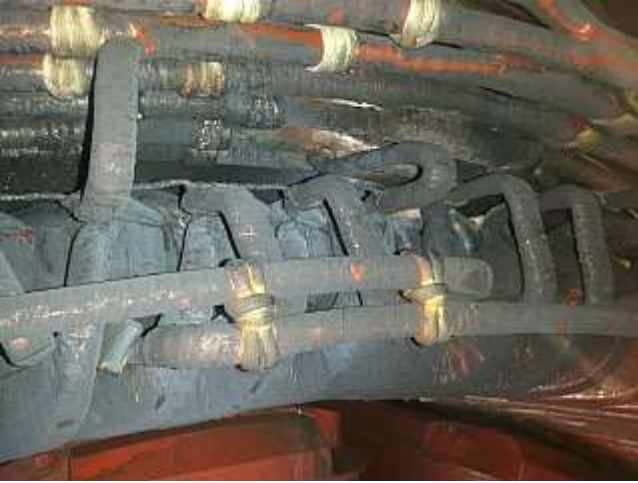
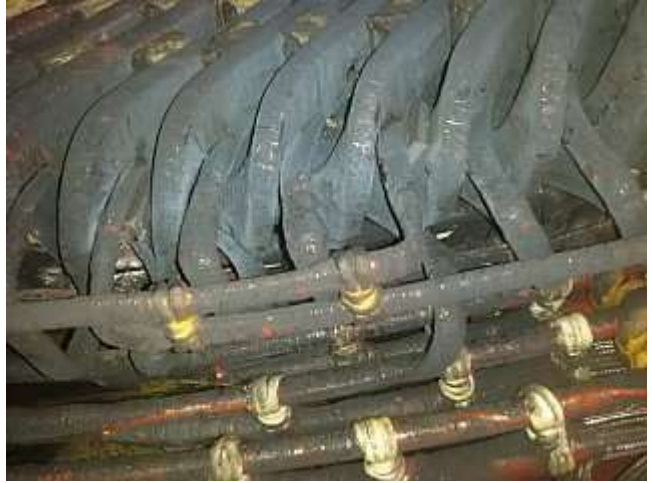
2- AFTER SHORT CIRCUIT AND EXPLOSION, THERE HAS BEEN CARBONIZED AND BURNED INSULATION POINT.

3- END-POINTS OF CABLES FROM STATOR COIL TO THE POWER TERMINAL BOX SHALL BE CLEANED AND INSULATIONS SHALL BE REPLACED.

4- AFTER INSULATIONS AND REPAIR WORKS REPAIRED POINT MUST BE VARMISHED AND DRIED.
